Driven by performance

ENGINE BEARING:

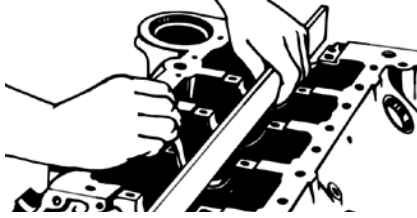
2. Check main bearing bores for alignment, taper, roundness and size. Check condition of bolts and threads.

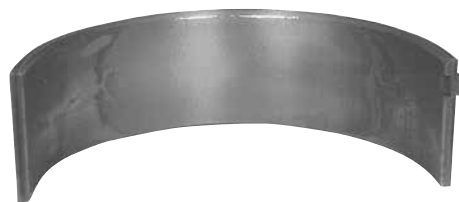
For technical service call:
1-800-248-9606

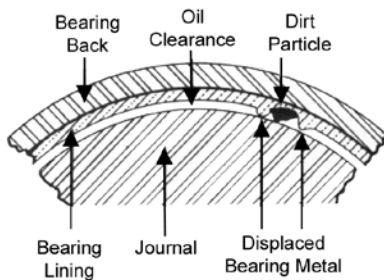
6 Foreign particles on bearing back

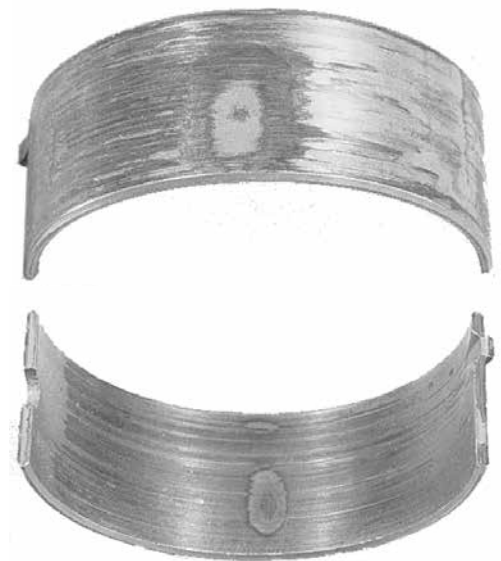
1. Install new bearings following proper cleaning and burr removal procedures for all surfaces.
2. Check journal surfaces and if excessive wear is discovered, regrind.

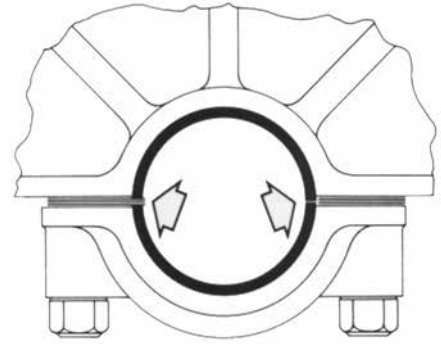
Shims improperly installed

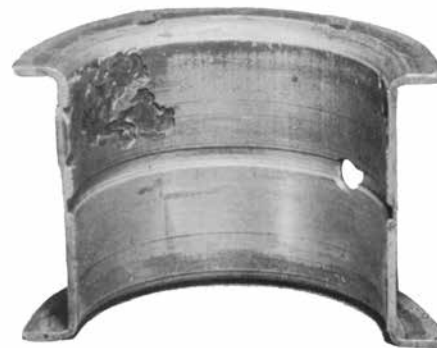
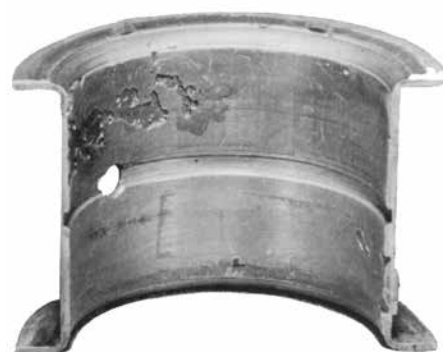
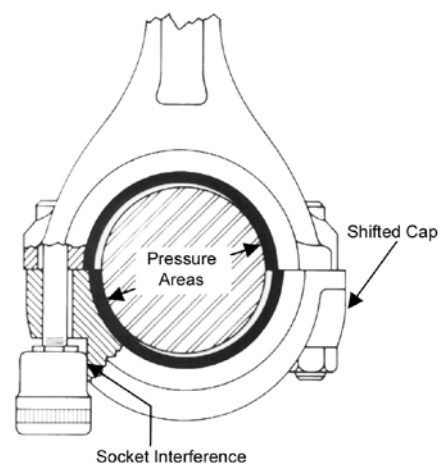
1. Check journal surfaces for excessive wear and regrind if necessary.
2. Install the new bearing being careful to use the correct size socket to tighten the cap and the correct size dowel pins (if required).
3. Alternate torquing from side to side as to assure proper seating of the cap.
4. Check the bearing cap and make sure it's in its proper position.
5. Use new bolts to assure against overplay within the bolt holes.

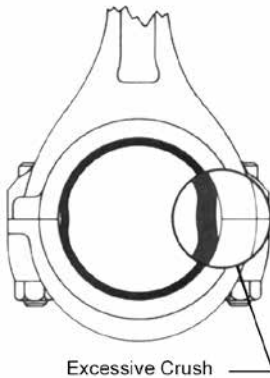
When there is too much crush, however, the additional compressive force created by the surplus crush that still remains after the bearing is fully seated causes the bearing to bulge inward at the parting faces. This bearing distortion is called “side pinch.”

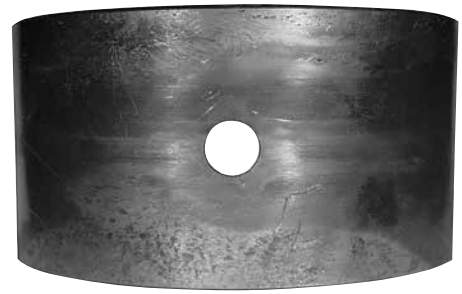
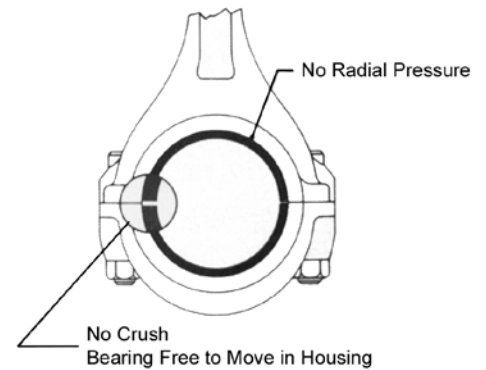
11 Bent or twisted connecting rod

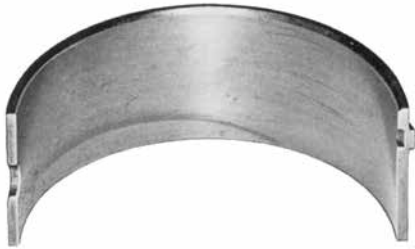
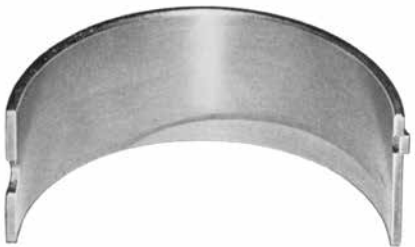
1. Inspect connecting rod and recondition or replace if bent or twisted.
2. Check journal surfaces for excessive wear and regrind if necessary.
3. Install bearing.
4. Avoid dropping or abusing the connecting rod prior to assembly.
5. Use proper installation techniques.
6. Check related upper cylinder parts and replace if necessary.

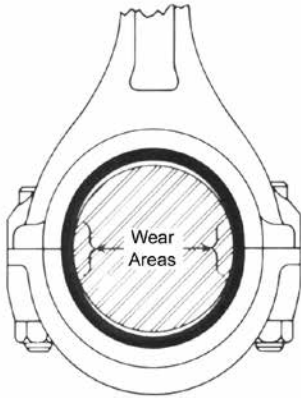
Also, improper seating between the bearing back and the housing bore may be present which hinders proper heat transfer causing localized heating of the bearing surface and thus reducing fatigue endurance.

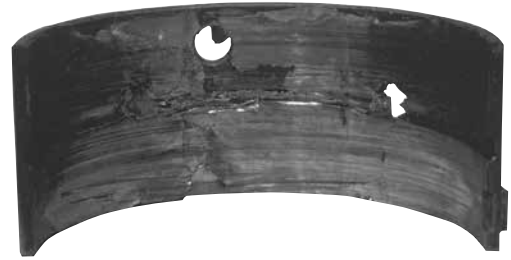
1. Foreign Particles in Lining (Page 8)
2. Foreign Particles on Bearing Back (Page 9)
3. Out-of-Round Bore (Page 18)
4. Excessive Crush (Page 12)
5. Bent or Twisted Connecting Rod (Page 14)
6. Shifted Bearing Cap (Page 11)
7. Distorted Crankcase (Page 16)
8. Bent Crankshaft (Page 17)
9. Oil Starvation (Page 20)
10. Misassembly (Page 10)

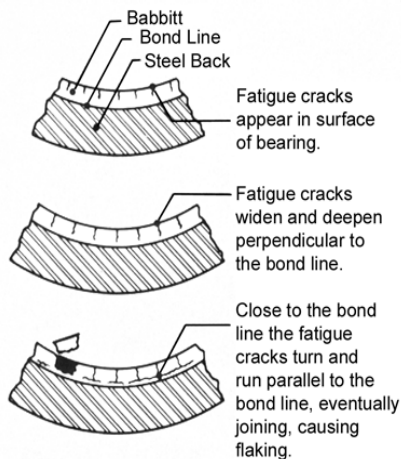
1. If the service life for the old bearing was adequate, replace with the same type of bearing to obtain a similar service life.
2. If the service life of the old bearing was too short, replace with a heavier duty bearing to obtain a longer life.
3. Replace all other bearings (main connecting rod and camshaft) as their remaining service life may be short.
5. Check for misassembly. Use proper installation techniques.

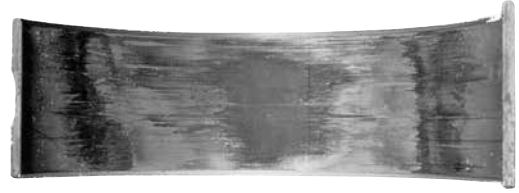
This is usually the result of contamination of the oil from either the fuel system or internal engine leaks. This condition is further pronounced when there is poor routine maintenance.
